# **X-PRESS PEARL MARITIME DISASTER SRI LANKA**

**REPORT OF THE UN ENVIRONMENTAL ADVISORY MISSION  
JULY 2021**

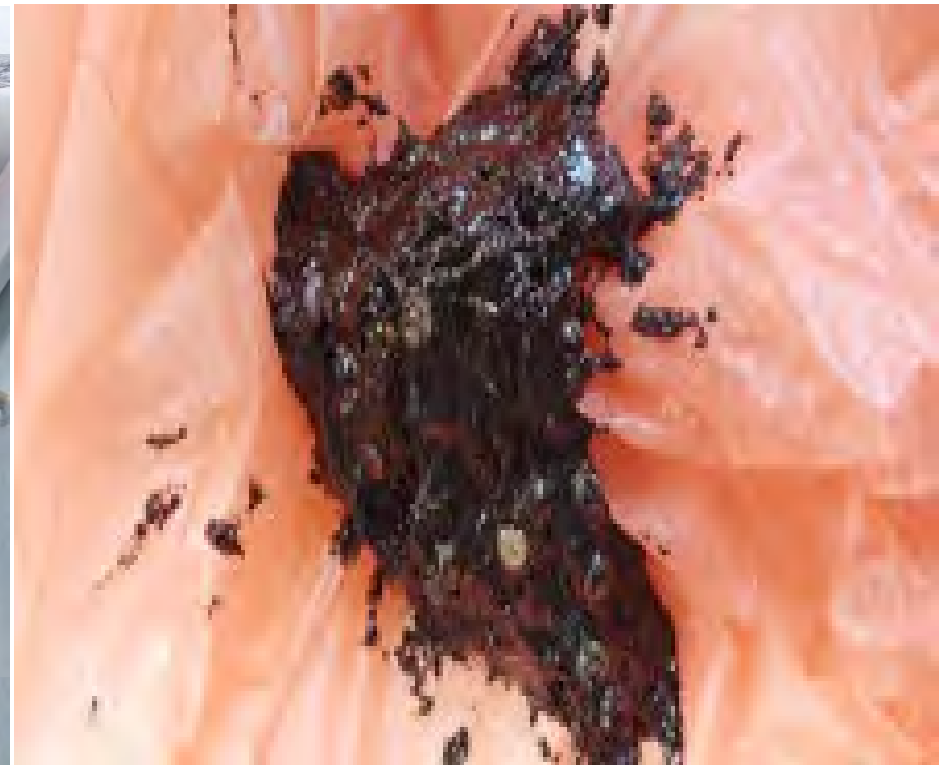
Figure 2.5: Sample of oil and pellets collected on 21 June 2021.

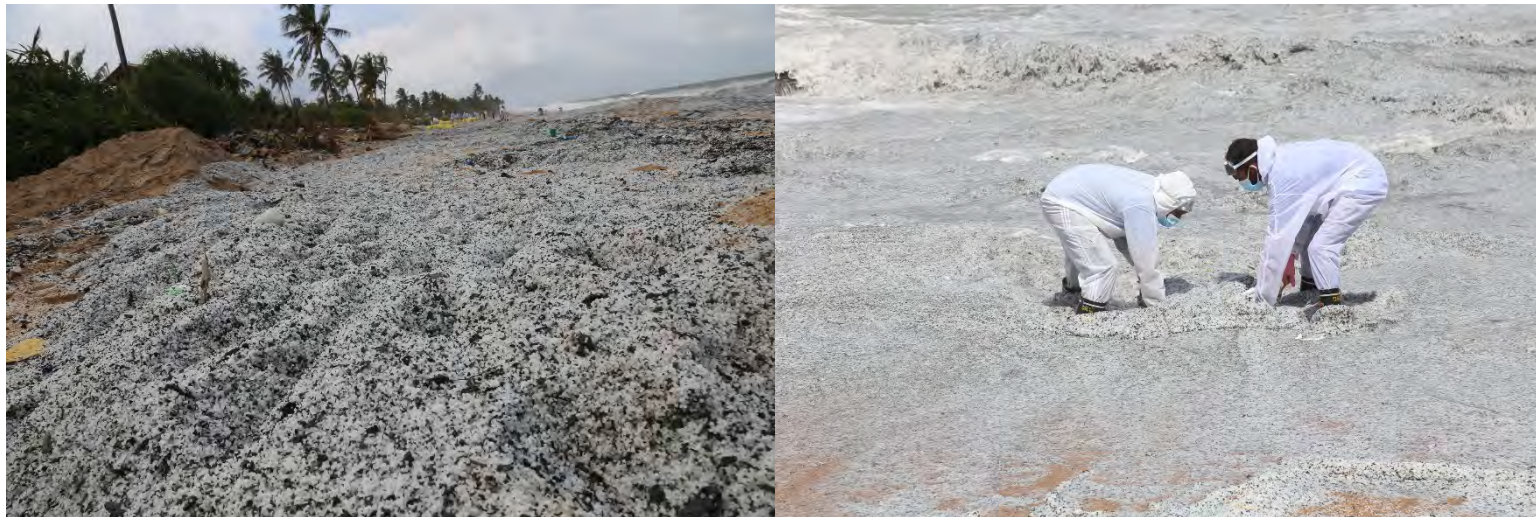
**Figure 2.13:** Massive arrival of plastic pollution on the west coast of Sri Lanka following the incident (credit: MEPA).

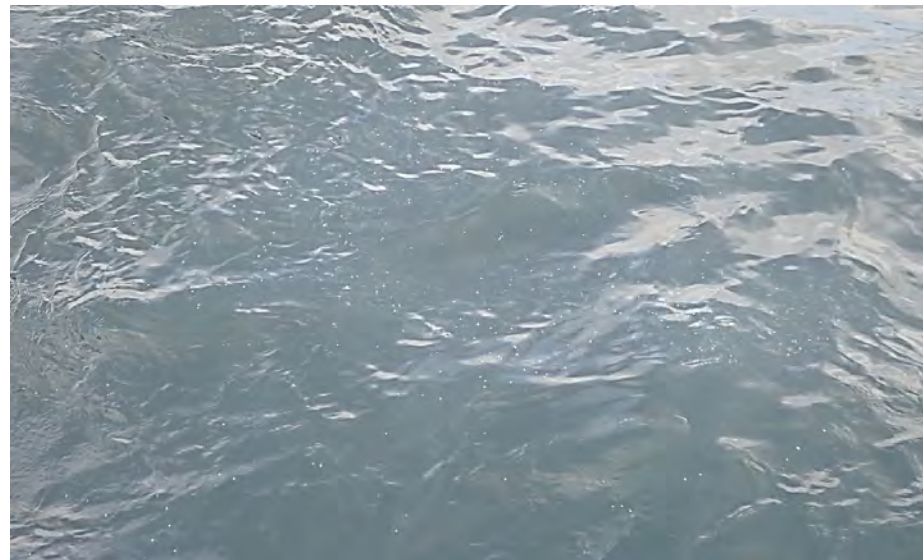
**Figure 2.14:** Plastic pellets floating in the oil slick near the wreck, boat survey on 20 June.

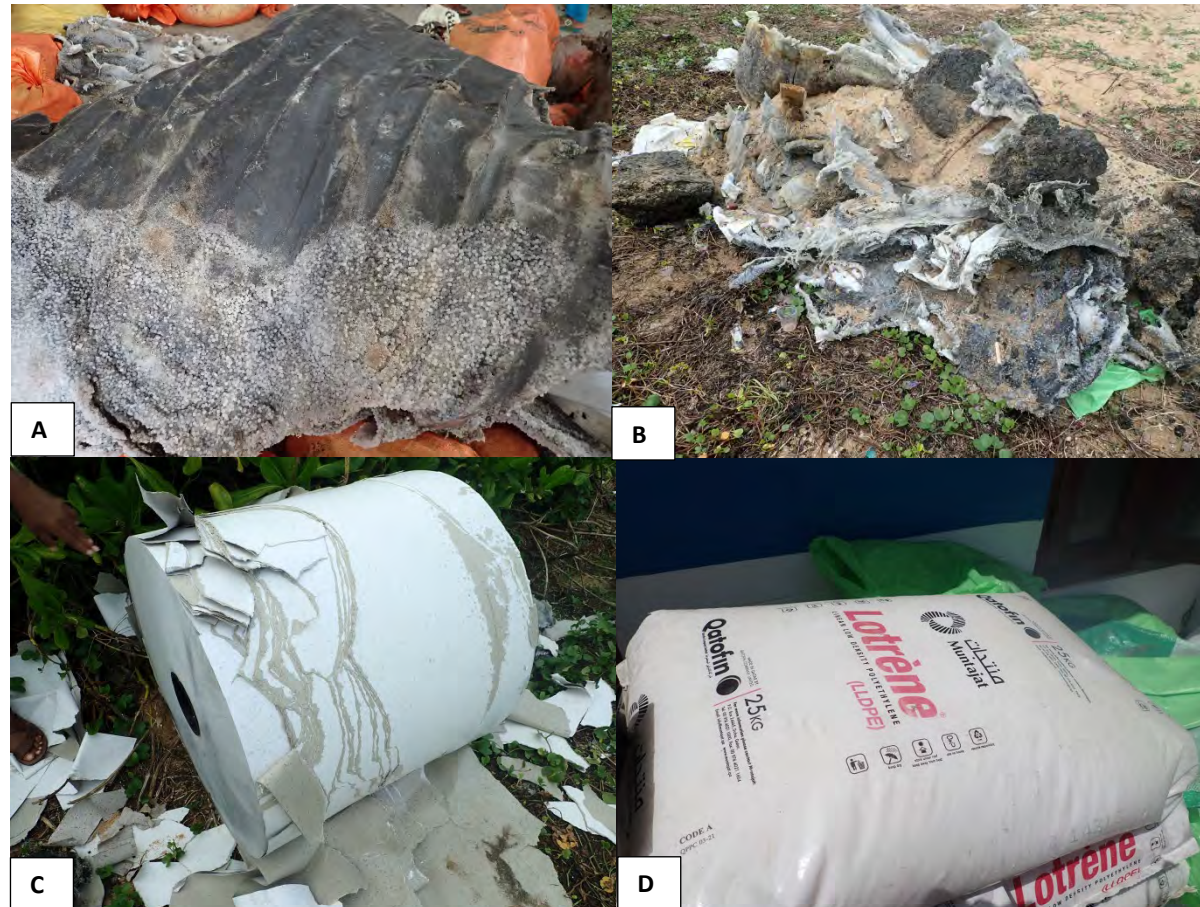
**Figure 2.15:** Large items collected on the coastline in Sarakkuwa and Dungalpitiya, Gampaha district.  
A and B: pieces of burnt plastic pellet bags; C: cardboard roll and D: Intact plastic pellet bag.

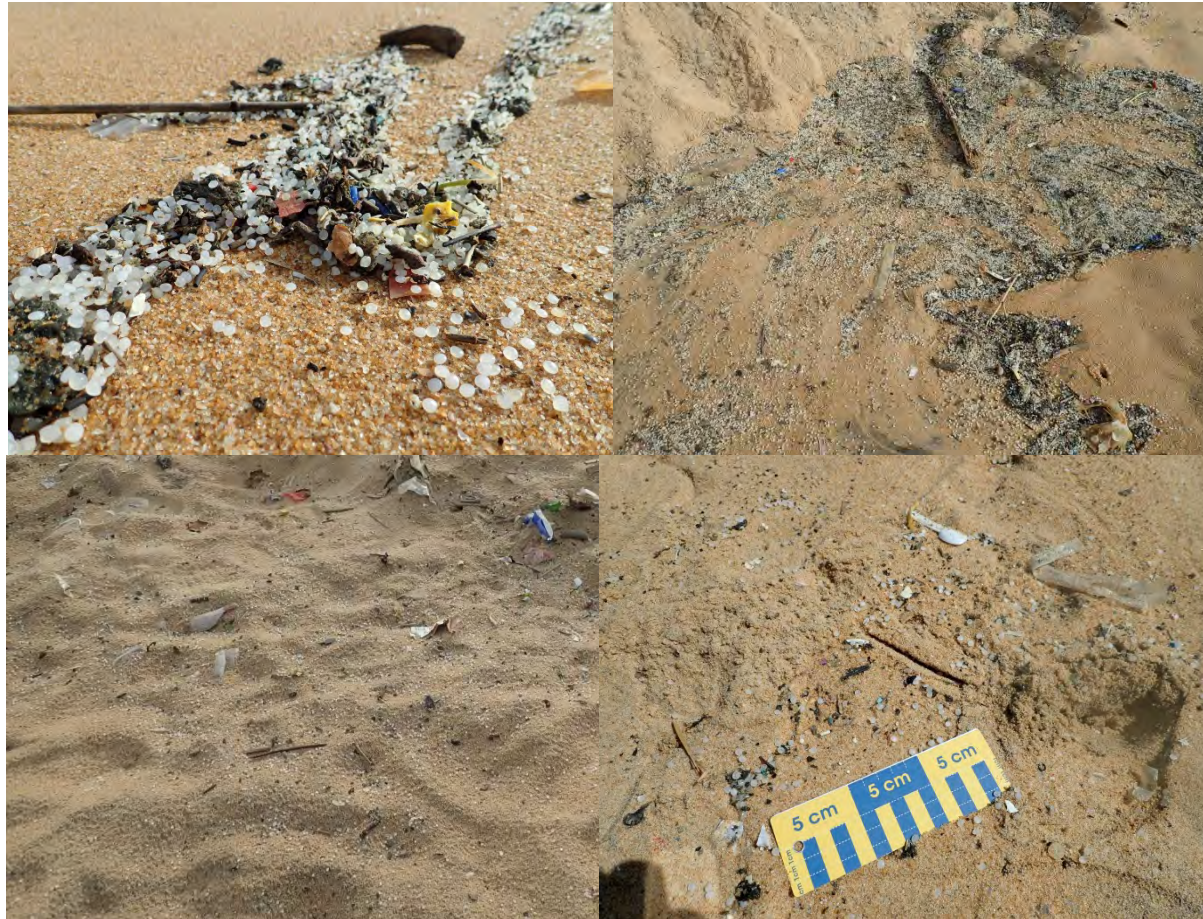
**Figure 2.16:** Pellets and small burnt plastic pieces deposited in recent strandlines or mixed in the first layer of sand in Sarakkuwa beach, Gampaha district.

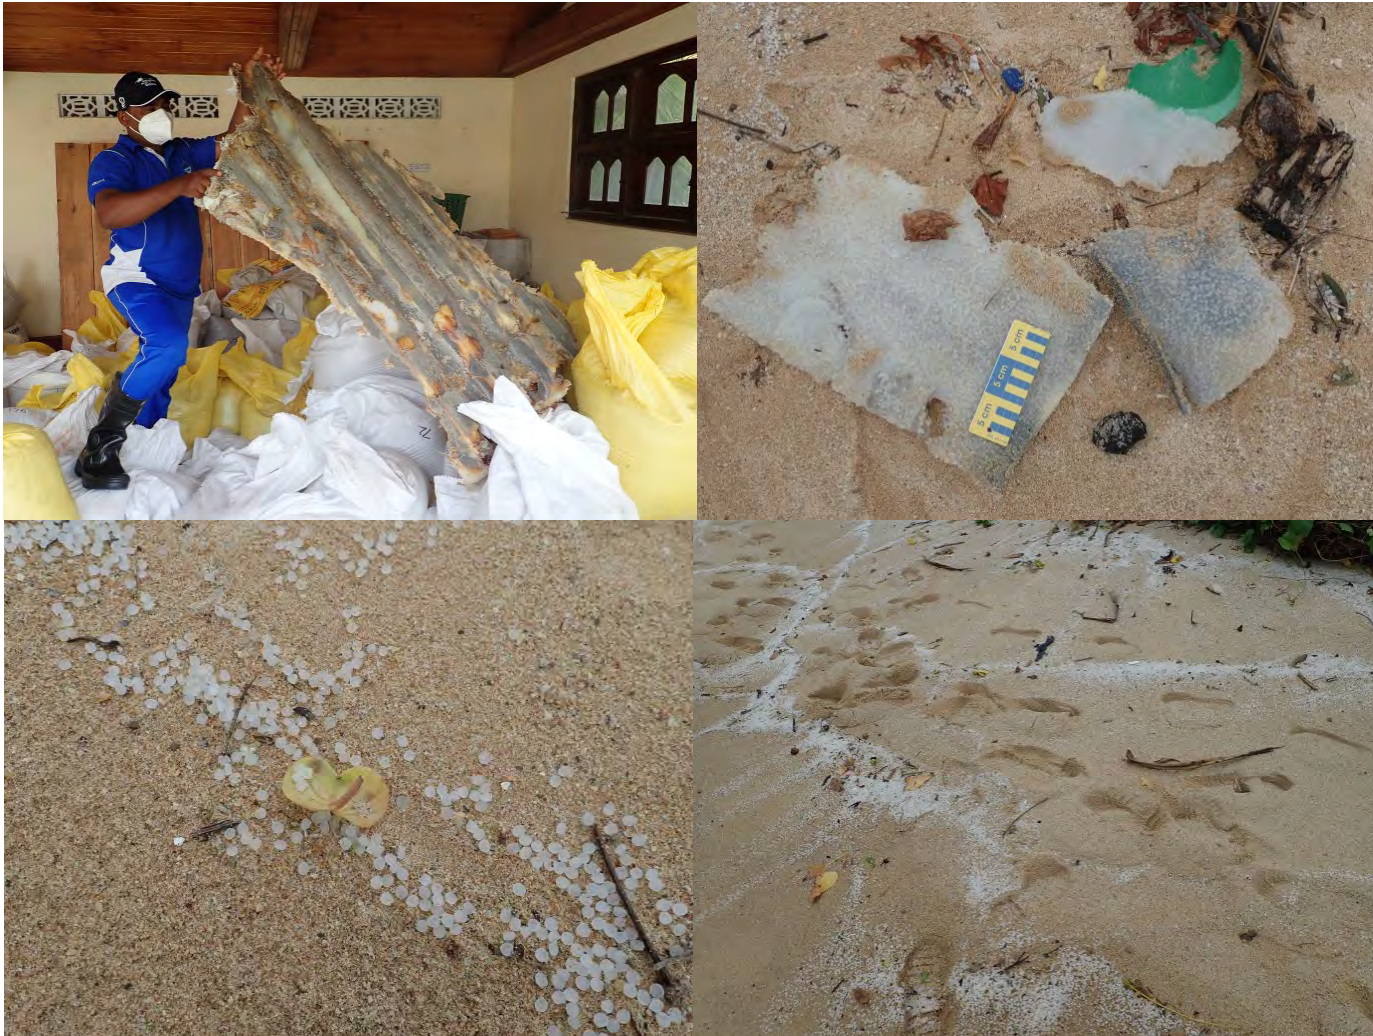
Along the southern coast, the larger debris has been collected and remaining pollution is constituted of virgin LDPE pellets and fragments of melted pellet bags. Though exposed to massive pellet arrivals, the situation along the southern shorelines is relatively less challenging due to the limited diversity of pollutants and absence of burnt plastic pieces.

Figure 2.18: Melted pellet bags and LDPE pellet on the Matara coastline.

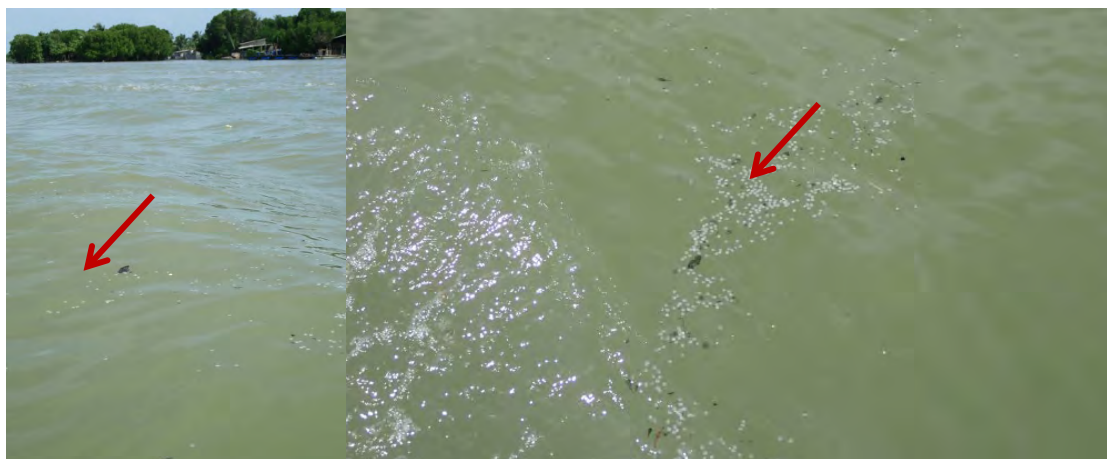
The inlets of the Negombo Lagoon – a major fishing ground situated near the most impacted sites – were partially protected by the deployment of booms along the two entrance channels. It is estimated that the booms may have prevented up to 80% of the plastic pollution from entering the lagoon. These booms had been removed by the time of the UN team's visit. Though clean-up campaigns have been conducted, the UN team was able to observe patches of pellets and burnt plastic fragments during a boat survey in the lagoon on 24 June. Recovery of floating plastic pollution in the lagoon inlet (e.g. using small meshed nets) should be considered before it disseminates deeper in the lagoon or enter mangrove stands. Chronic pollution of lagoon water may also make the microplastics a long-term hazard as pollutants adsorb on them and enter the food chain.

**Figure 2.19:** Floating pollution in inlets connecting Negombo lagoon with the ocean; pellets and burnt plastic fragments, Gampaha district.

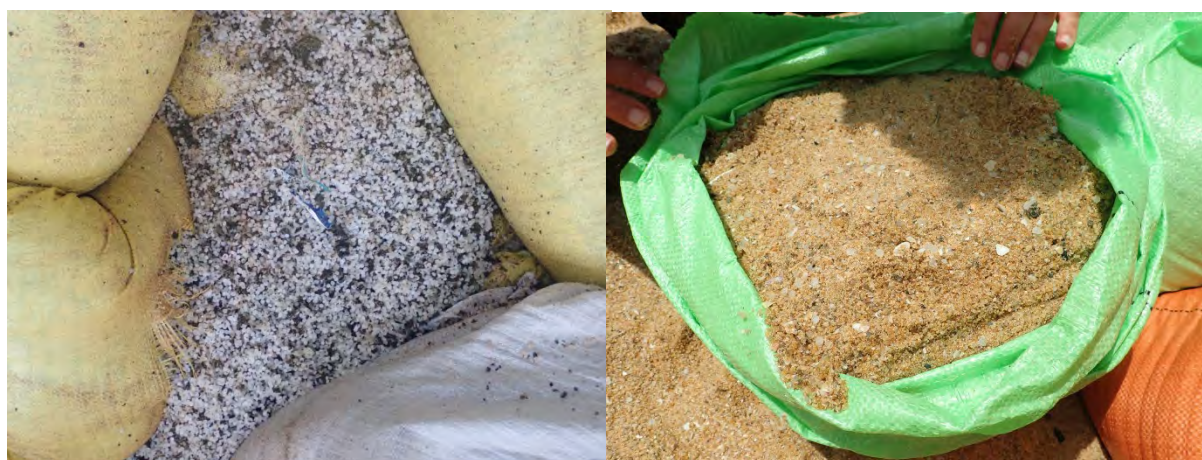
**Figure 2.20:** Evolution of bag content on Sarakkuwa beach, Gampaha district. On the left, content of bags at the beginning of the clean-up campaign, and on the right after several weeks.

A phased approach is being applied to plastic pellet recovery. Bulk arrivals of nurdles mixed with other debris was initially hauled manually using large baskets and heavy equipment. As the clean-up progressed and reached an advanced stage, the quantity of nurdles collected decreased while that of sand increased, especially when shovels are used to scoop up the pellets. It was observed that a substantial number of bags contain a large proportion of sand, which in some cases can reach up to 80 percent. Additional treatment will be required to separate the sand from the pellets.

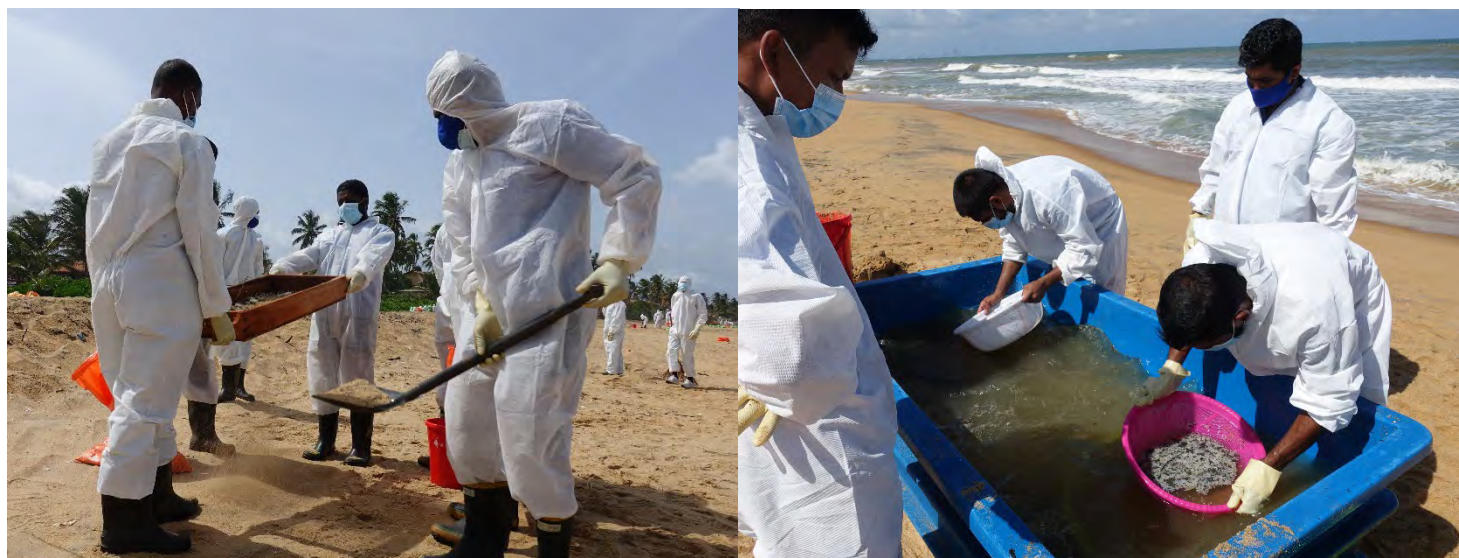
**Figure 2.21:** Left: Manual sieving, Right: flotation in seawater. Sarakkuwa beach, Gampaha district.

Flotation appears to be the more effective option, reduces the volume of sand collected, and offers the possibility of separating and recovering small burnt fragments. Guidance on scaling-up this density-based separation method is needed.

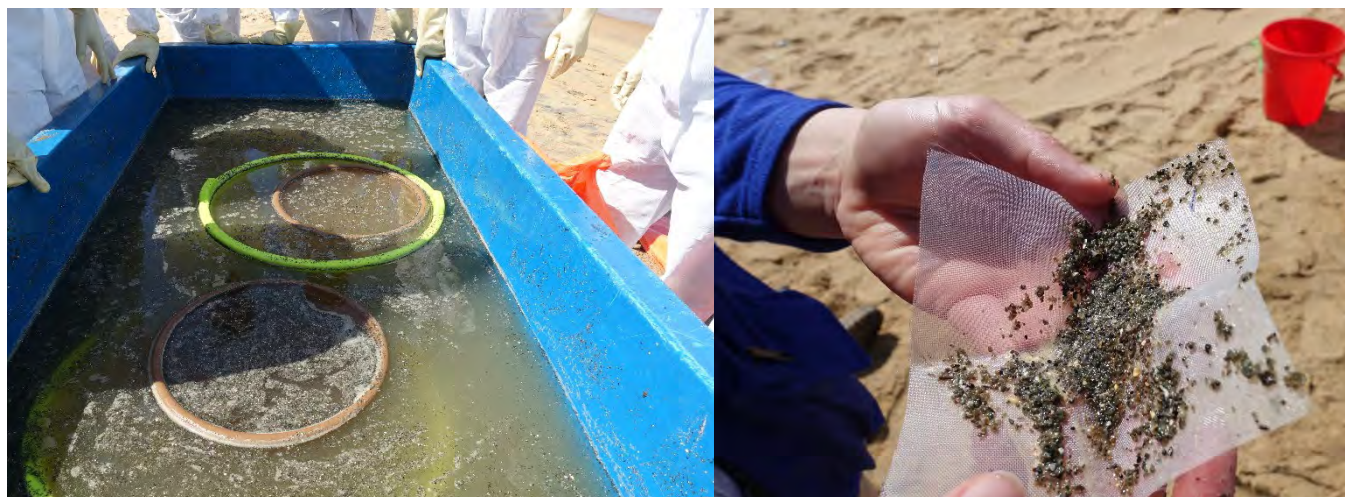
The burnt plastic fragments represent a challenge for the clean-up as they appear to be very brittle and easily breakdown into small irregular shaped particles; whereas pellets are solid, round and of standard size. Significantly, the degradation of the burnt fragments can be augmented by mechanical clean-up techniques. Moreover, the smaller particles with an irregular shape and a size inferior to pellets (3 mm) are generally not recoverable with techniques such as manual flotation or sieving due to large mesh size. Methods to recover these small burnt plastic flakes need to be developed. Furthermore, the extent of the remaining burnt plastic pollution in the sand is currently unknown and needs to be assessed.

**Figure 2.23:** Burnt plastic particles left after flotation that are too small to be recovered with existing sieves.

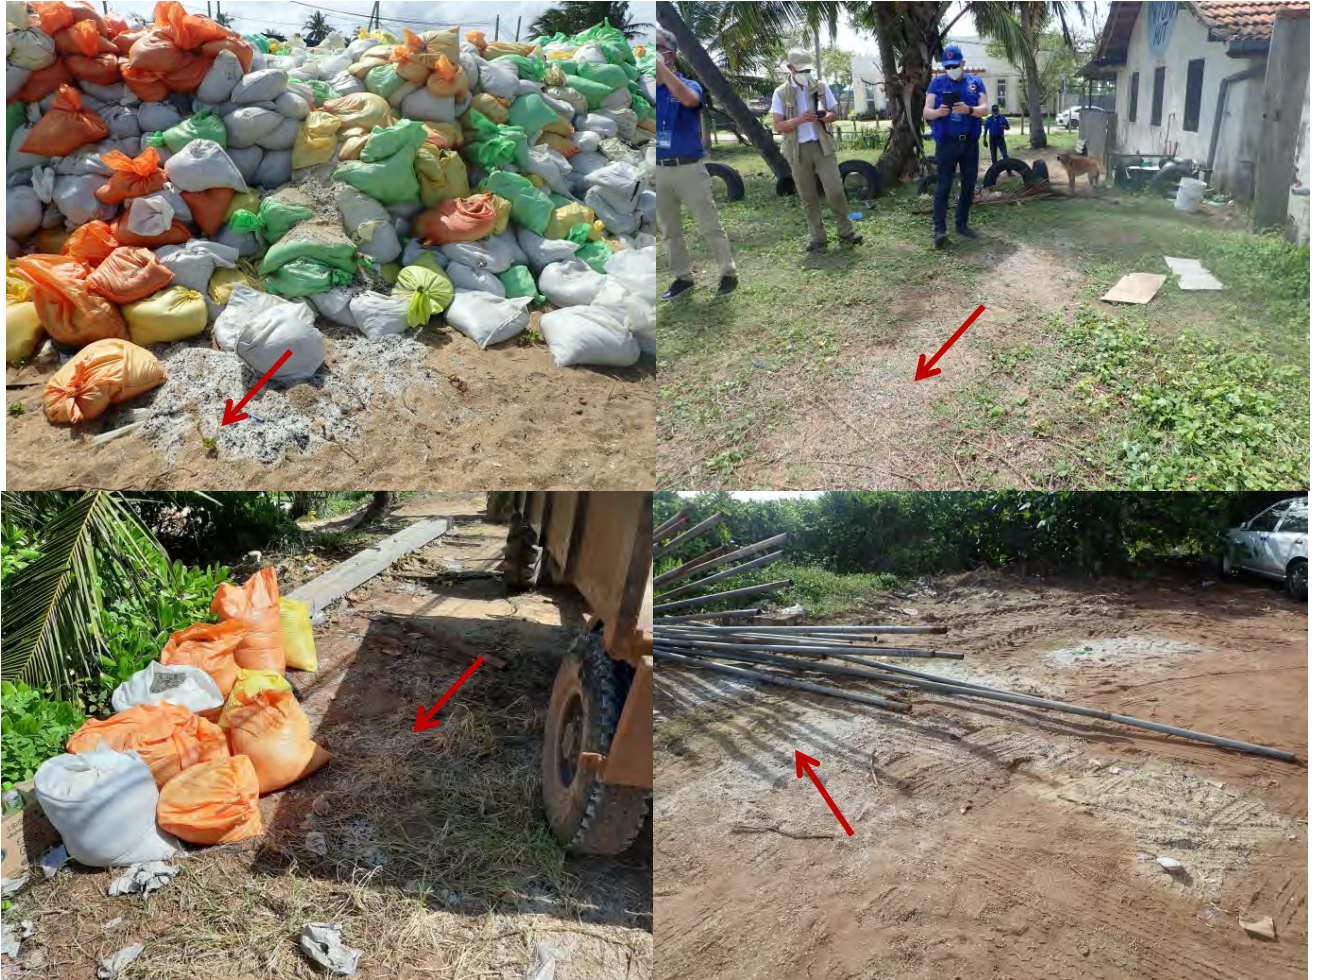
Inadvertent release of pellets during transport is another problem. Specifically, leakages during bag transport from the beach to the main road - where continuous traces of plastic pellets could be observed along footpaths and in the vegetation, including in private residences – is an issue of concern. Improvement of on-site storage and proofing of transport methods to avoid contamination is therefore needed.

**Figure 2.24:** Secondary pollution on the backshore of the beach, on paths used to transport bags and along the road, Sarakkuwa and Dungalpitiya beach, Gampaha district.

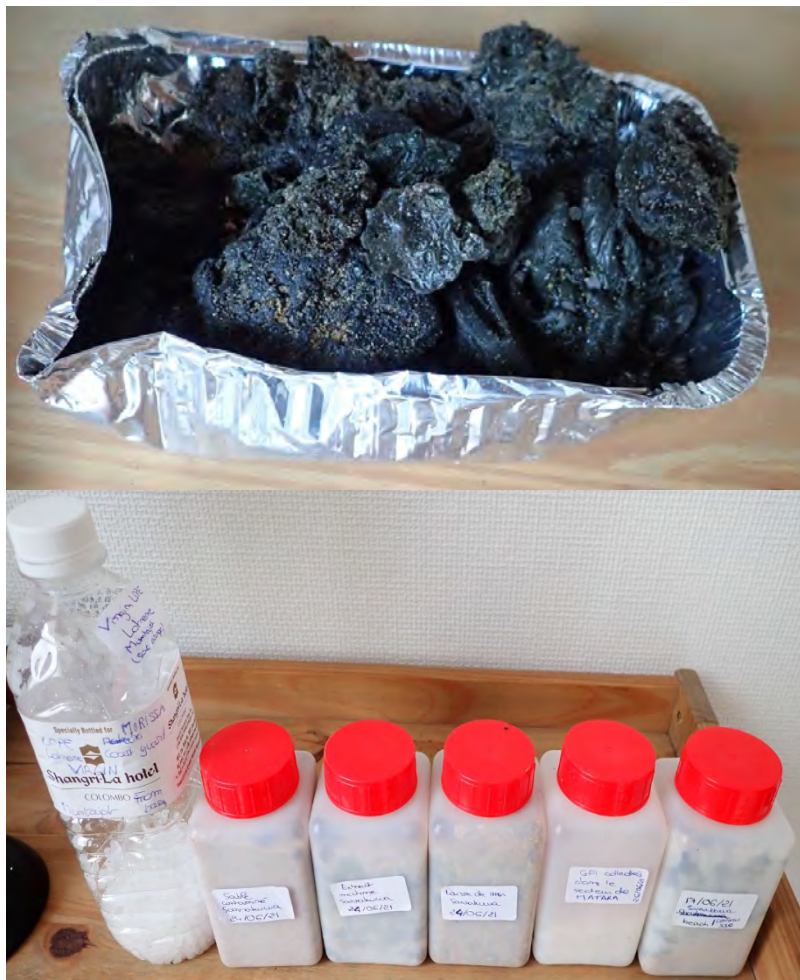
**Figure 2.25:** Burnt plastic pieces and pellet samples collected on different beaches.

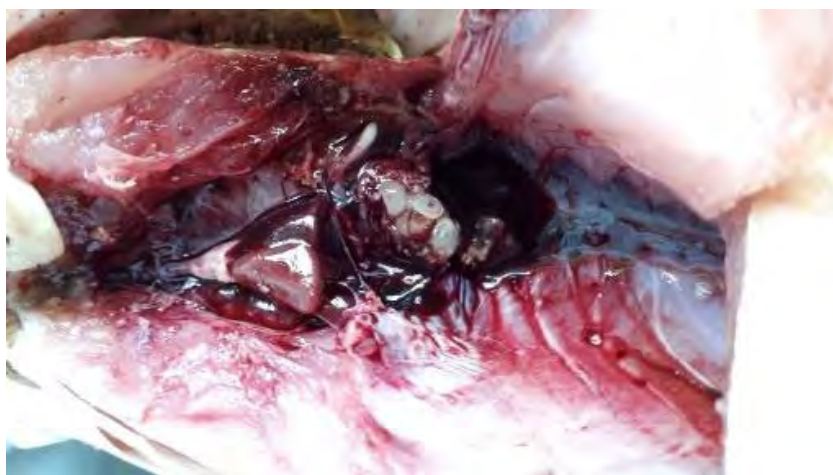
While there is a potential risk of fish accidentally feeding on pellets, there is limited evidence so far that this has occurred. Analysis of dead fish found ashore and live samples collected through experimental fishing by the National Aquatic Resource Agency (NARA) have so far found few specimens with pellets lodged around their gills.

**Figure 2.28:** Giant trevally (*Caranx ignobilis*) with plastic pellets in pharynx (credit: NARA).

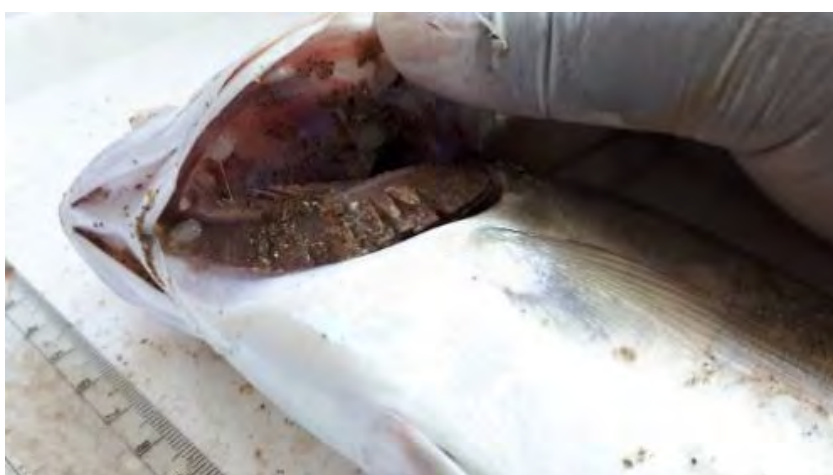
**Figure 2.29:** Gold silk sea bream (*Acanthopagrus berda*) with plastic pellets in opercle (credit: NARA).

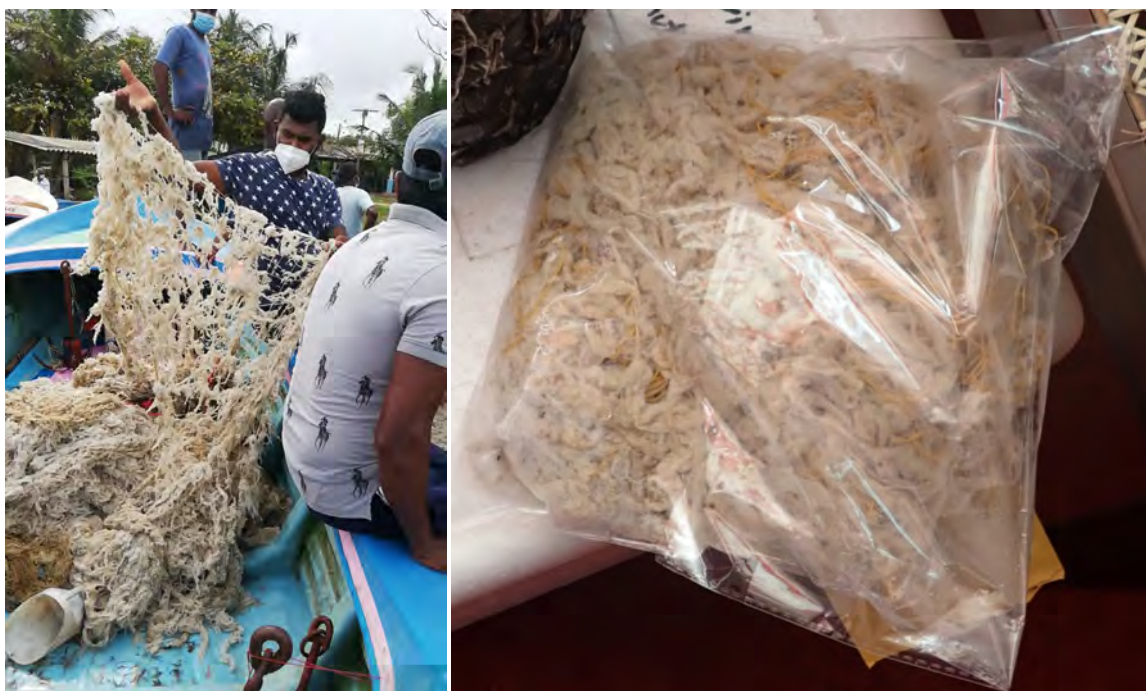
There are also reports of dissolved nets, which the UN team was not able to directly verify. If this is confirmed, then damage to other shipping assets (e.g. boats) may have also occurred. In addition to the replacement cost of the nets, their loss can heavily impact fisherman earnings for the whole season.

Figure 2.30: Nets entangled with synthetic fibres (left, credit: MEPA).

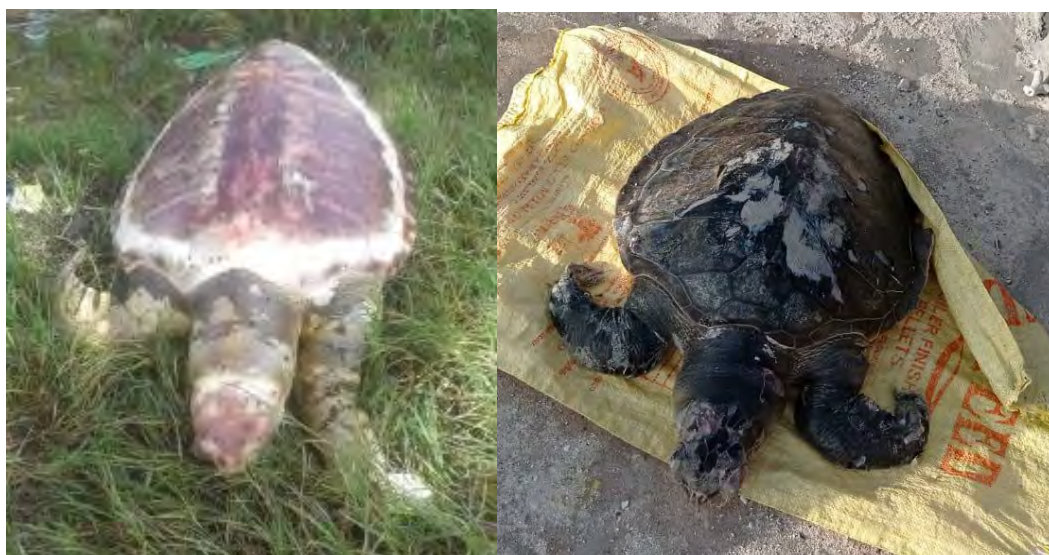
**Figure 2.31 (left):** Turtle with bleached shell suggesting potential burn (credit: Department of Wildlife Conservation).

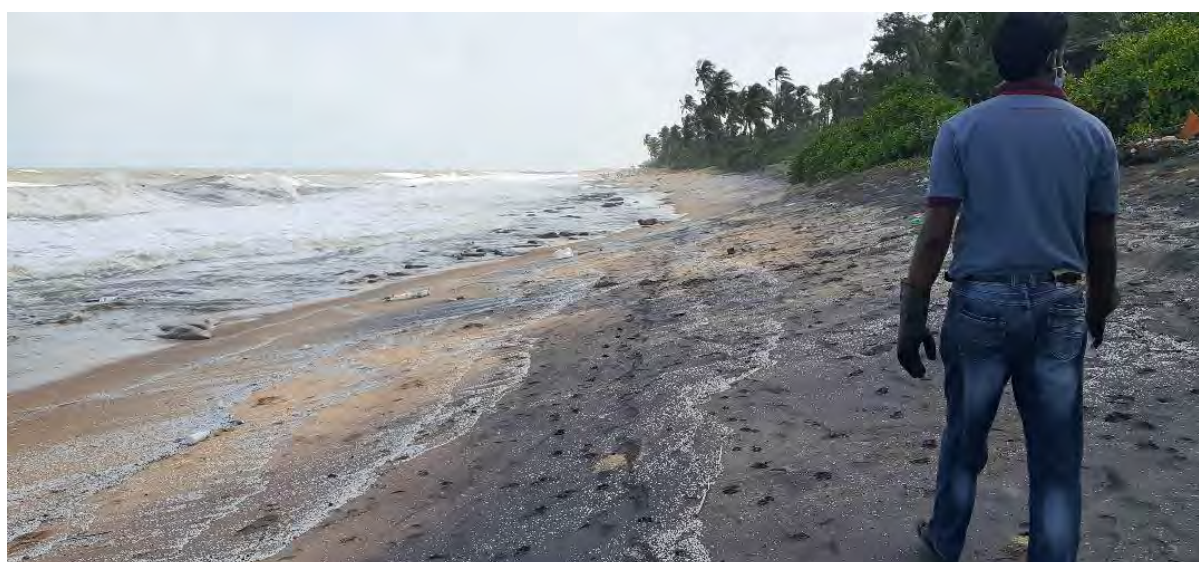
**Figure 2.40:** Depositor of fire residue on the shoreline (credit: NBRO).

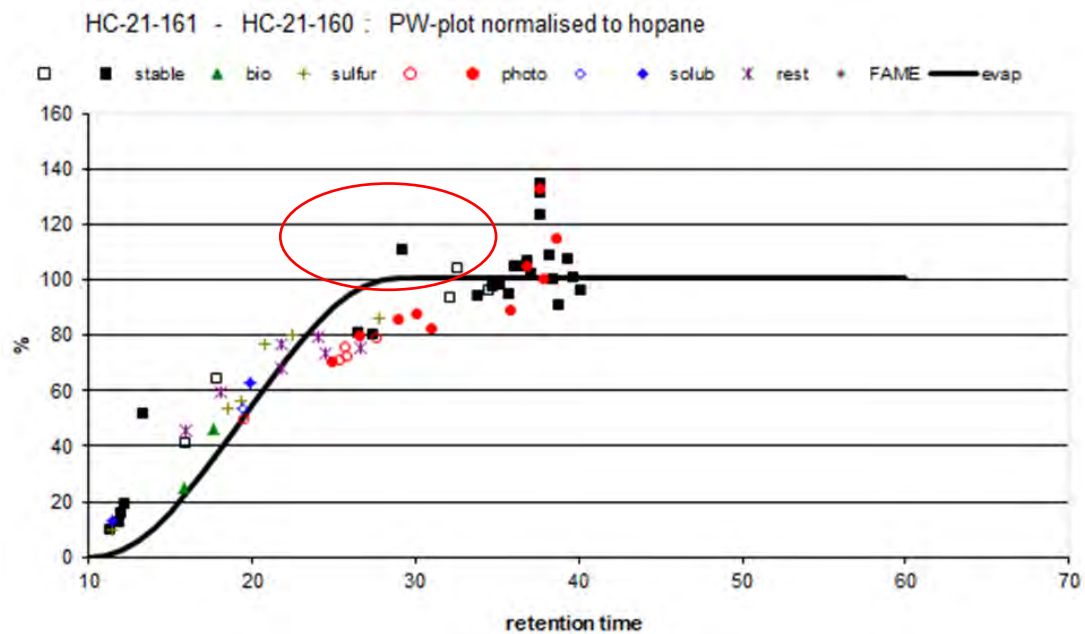
**Figure 2:** Full concordance for compounds in the red circle. The statistical treatment of analysis does not show significant difference between the two oil samples taken.
